VERTEX MINERALS LIMITED
ACN 650 116 153

Rehabilitation Management Plan

(Care & Maintenance)

Reward Gold Mine

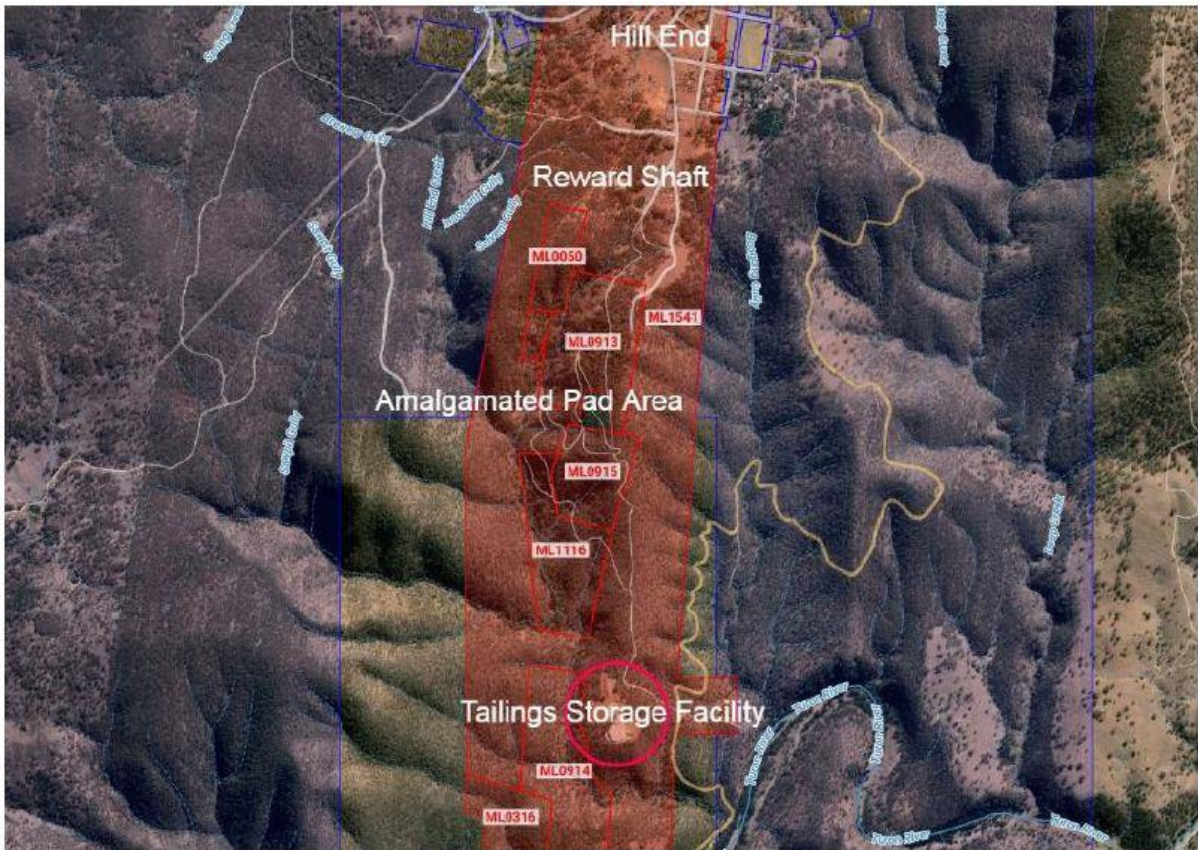
Figure 11: Location of Tailings Storage Area (Red Circle) – Obtained from Landloch Report (2020)

The TSF site is located within the southern part of the Reward Mine and is situated on a ridgeline (Figure 11). Hill End Creek is located to the west and downslope of the TSF, within a gully. The TSF is situated on Mining Lease ML1541. It is located on the southern face of Hawkins Hill and covers an area of approximately 3.5 ha. The TSF is approximately 1.3 km down gradient from the Amalgamated Pad Area.

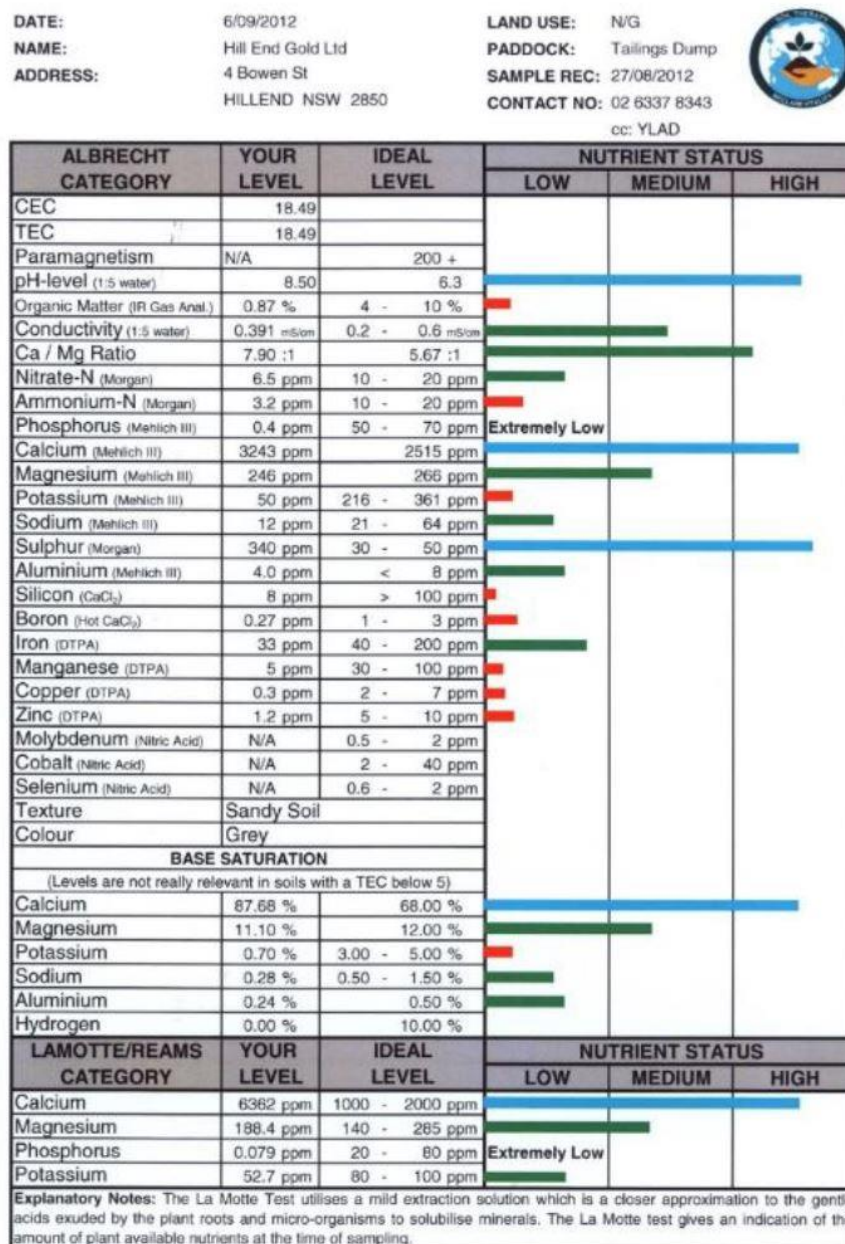
Figure 13: TSF Material Analysis

The aim of the trials was to determine if it is possible to re-vegetate the tailings material. What type of vegetation, if any, will grow in it and what other inputs would be required and at what rates?

A sample of the fine waste material was sent for analysis, with details of that analysis shown in Figure 13 below.
